OXIDATION AND EMBRITTLEMENT IN SILICIDE-COATED COLUMBIUM-ALLOY  
AND ALUMINIDE-COATED TANTALUM-ALLOY SHEET

By Bland A. Stein and W. Barry Lisagor  
National Aeronautics and Space Administration  
Langley Research Center, Langley Station, Hampton, Va.

Presented at the Fourth Symposium on Refractory Metals,  
Institute of Metals Division, The Metallurgical  
Society of AIME

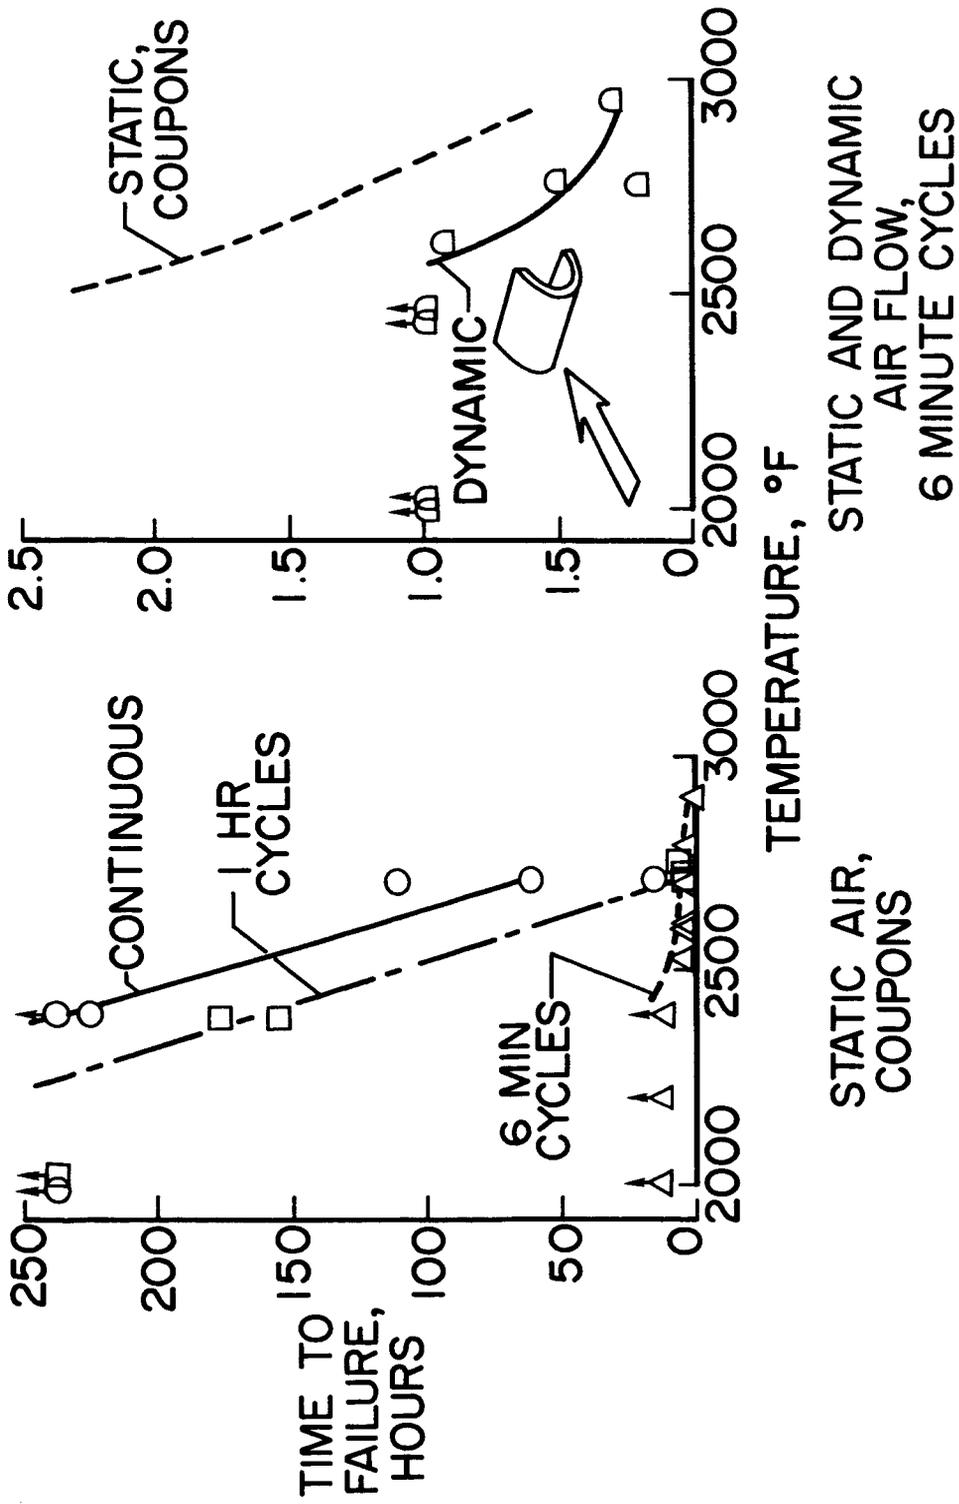
Figure 1.- Oxidation test results for Cr-Ti-Si (silicide) coated Cb-10Ti-5Zr alloy sheet at atmospheric pressure.

Oxidation. - Results of oxidation tests on the Cr-Ti-Si coated Cb-10Ti-5Zr alloy are shown in figure 1. Arrows indicate that the specimens did not evidence oxidation failure. The graph at the left shows the results of static tests. One-hour cyclic exposure specimens exhibited considerably lower times to failure than continuously exposed specimens and the 6-minute cycles reduced

coating life significantly at temperatures above 2400° F, but adequate oxidation resistance for some thermal protection applications was provided by the coating at temperatures up to at least 2400° F.

The graph at the right in figure 1 shows the results of dynamic oxidation tests on leading-edge segments as compared to results of static tests on coupon specimens in 6-minute cyclic tests (reproduced from the graph at the left). The mass-flow condition further lowered failure times above 2400° F but adequate oxidation lifetimes for some thermal protection applications were again retained to at least 2400° F.

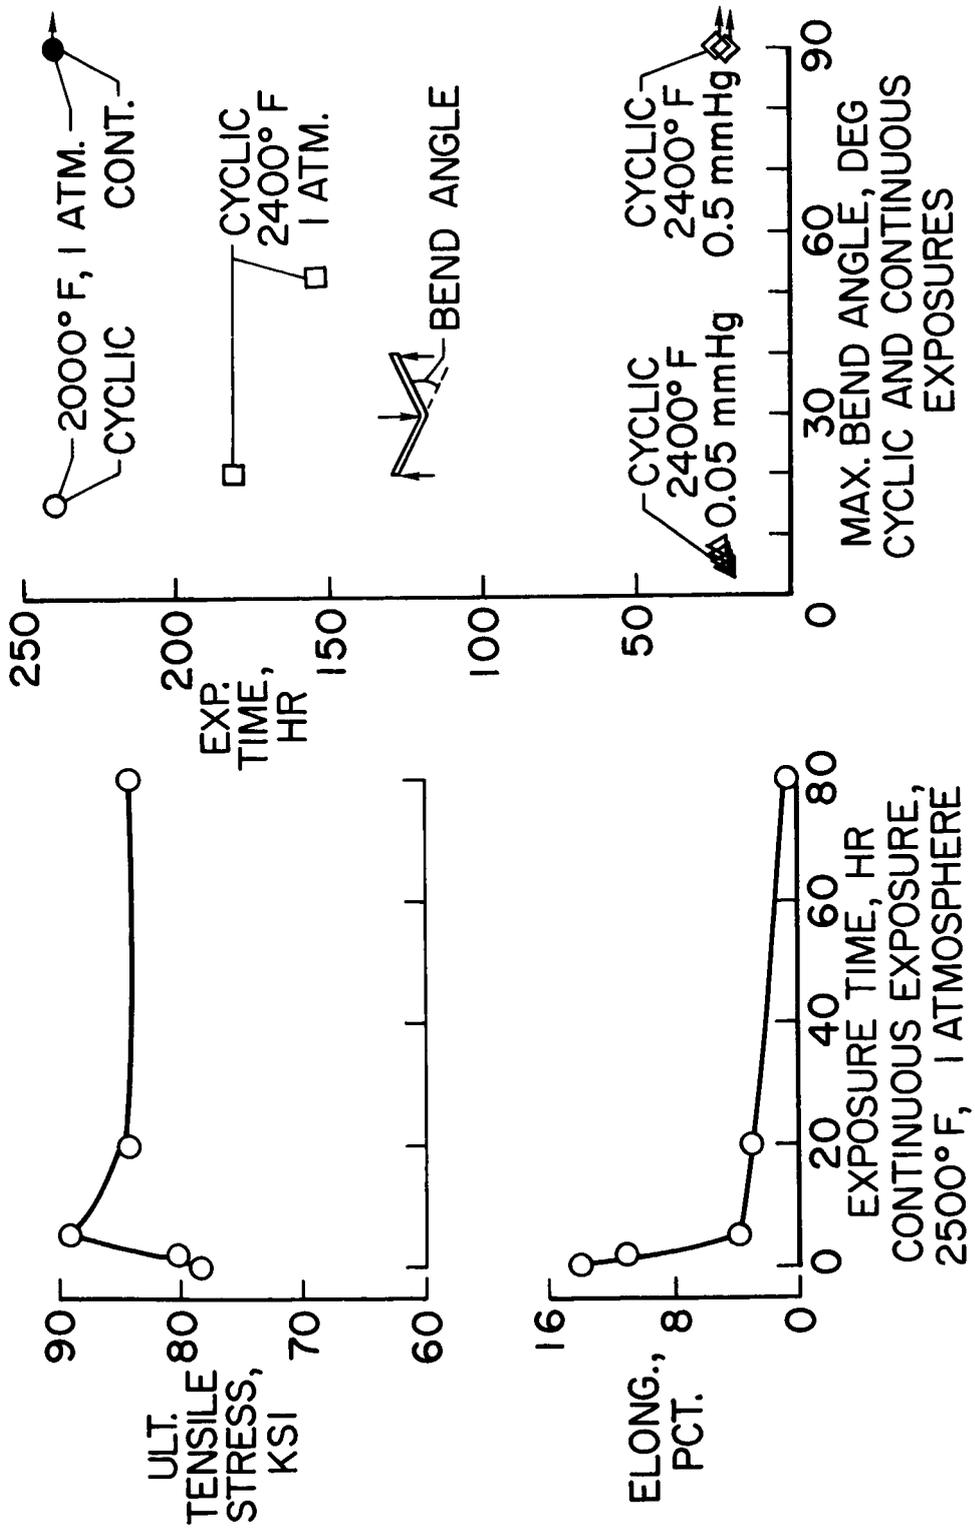
Figure 2.- Room-temperature tensile and bend test results for Cr-Ti-Si (silicide) coated Cb-10Ti-5Zr alloy sheet.

Embrittlement.- The results of room-temperature tensile and bend tests on the silicide-coated columbium alloy are shown in figure 2. In general, these results indicate that significant substrate embrittlement can result from high-temperature exposures at times considerably prior to general coating failure. The curve at the upper left indicates that ultimate tensile strength is not significantly affected by continuous exposures up to 80 hours at 2500° F. However, the corresponding tensile elongation dropped from 14 percent as coated to 4 percent after 5 hours exposure and to 0 after 80 hours exposure as indicated at the lower left of figure 2. The effect of cyclic exposure can be even more severe in terms of embrittlement as determined from bend tests, as indicated in the graph on the right side of figure 2. After continuous exposure for 240 hours at 1 atmosphere and 2000° F, the specimen underwent a ductile 90° bend but under similar conditions in cyclic exposure, a specimen exhibited quite brittle behavior. Again at 1 atmosphere, 2400° F specimens exposed for 155 and 180 hours were progressively more brittle. At reduced pressures after 2400° F cyclic exposures bend test results differed markedly. Specimens subjected to 20-hour exposures at 0.5 mm Hg underwent ductile 90° bends while

specimens which had undergone similar exposures at 0.05 mm Hg were brittle. Metallographic studies in these cases indicated that substrate thickness losses due to solid-state diffusion of silicon were on the order of 0.001 inch at 2500° F for 50 hours. This amount of diffusion would not be expected to produce the substantial embrittlement noted above.

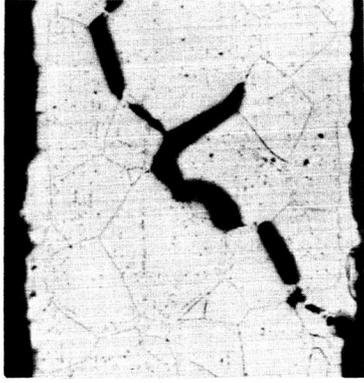
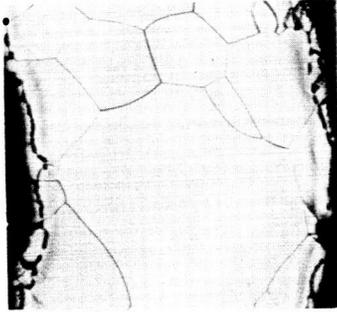
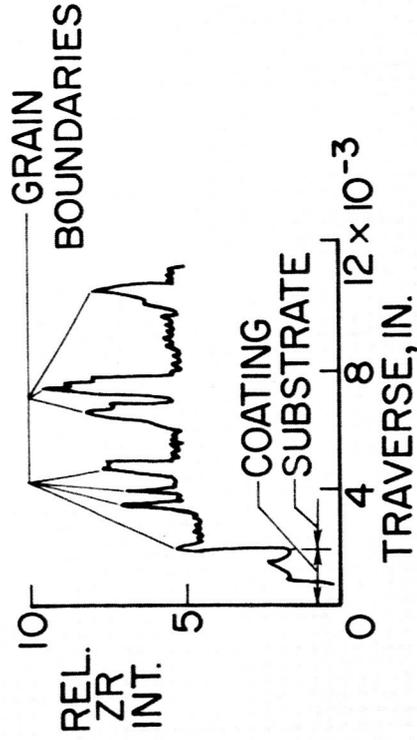
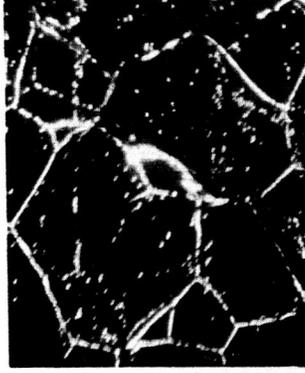
CYCLIC EXPOSURE,  
X100

CONTINUOUS EXPOSURE,  
X100

CYCLIC EXPOSURE,  
MICROPROBE TRACE

CYCLIC EXPOSURE,  
FLUORESCENCE UNDER  
ELECTRON BEAM, X150

Figure 3.- Photomicrographs and electron probe trace illustrating embrittlement mechanism for Cr-Ti-Si (silicide) coated Cb-10Ti-5Zr alloy sheet. Specimens exposed for 240 hours at 2000° F, bend tested at room temperature.

Embrittlement mechanism.- A possible mechanism for this embrittlement will be discussed with the aid of figure 3. In the upper left, the photomicrograph of the specimen which has undergone a ductile 90° bend after a continuous 240-hour exposure at 2000° F. Note the relatively clean grain boundaries in the substrate. At the upper right of figure 3, the specimen which underwent cyclic exposure is shown in a conventional photomicrograph, after cracking along the grain boundaries at a small bend angle. In this figure the grain boundaries show almost continuous precipitate networks. The lower right photograph of figure 3 shows the same area of the cyclic specimen taken by the light of grain boundary fluorescence under the electron beam of the electron probe microanalyzer. This fluorescence suggested that the particles in the grain boundaries might be oxides; the fluorescence was not noted in the continuously exposed specimen. A spectrographic electron probe trace of the embrittled specimen is shown at the lower left of figure 3. It indicates that zirconium in the substrate has concentrated in the grain boundaries. Recent results with the probe modified to detect the low atomic number elements indicate that oxygen has also concentrated at the grain boundaries. No significant grain boundary concentrations of other elements have been noted and no high grain boundary concentrations were noted for any elements in the ductile specimen.

On the basis of this information, it is postulated that oxygen has permeated through microscopic cracks which developed in the coating as a result of the thermal cycling. This oxygen apparently diffused throughout the substrate,

primarily along grain boundaries. The zirconium in the substrate diffused to the grain boundaries and reacted with the oxygen to form an embrittling network of zirconium oxide precipitate particles in the grain boundaries. It is possible that this embrittlement might not be as severe for other columbium alloys as for the Cb-10Ti-5Zr alloy investigated.

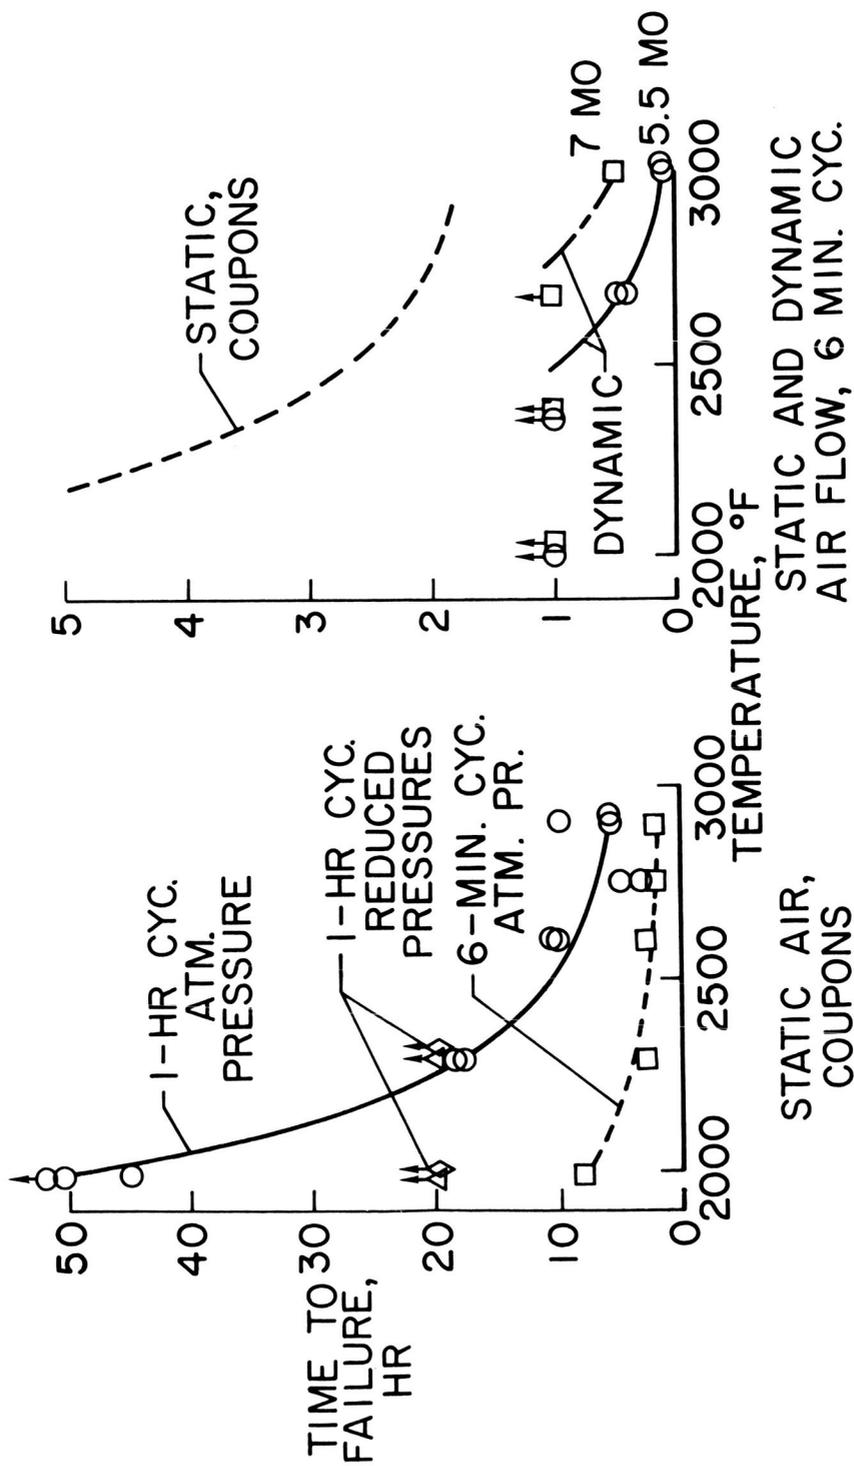
Figure 4.- Oxidation test results for Al-Sn-Mo (aluminide) coated Ta-10W alloy sheet.

Oxidation.- Results of oxidation tests on Al-Sn-Mo coated Ta-10W alloy are shown in figure 4. The graph at the left shows the results of static tests on coupons for two cyclic exposure conditions. In the 1-hour cycles at atmospheric pressure lifetimes ranged from about 50 hours at 2000° F to about 5 hours at 2900° F. Reduced pressure tests at both 0.5 and 0.05 mm Hg showed no failures within 20 hours at 2000° F and 2300° F, but indications of some coating evaporation were noted. This effect could severely limit the usefulness of this coating at these reduced pressures and higher temperatures. Equipment limitations have thus far precluded low-pressure testing at higher temperatures in our laboratories. The 6-minute cycles at atmospheric pressure reduced coating life considerably, as compared to the 1-hour cycles.

The graph at the right in figure 4 indicates the effect of dynamic oxidation testing on the life of coated-tantalum-alloy specimens. The static curve is reproduced from the graph at the left for comparison. The dynamic oxidation conditions in the arc-jet tests lowered coating lifetimes obtained under static conditions considerably at temperatures above 2600° F for the aluminide coating containing 5.5 percent molybdenum. A modified aluminide coating containing 7 percent molybdenum has been developed. As shown in figure 4, this coating has exhibited longer lifetimes in the dynamic oxidation tests. Some additional study of this recently developed modification is planned.

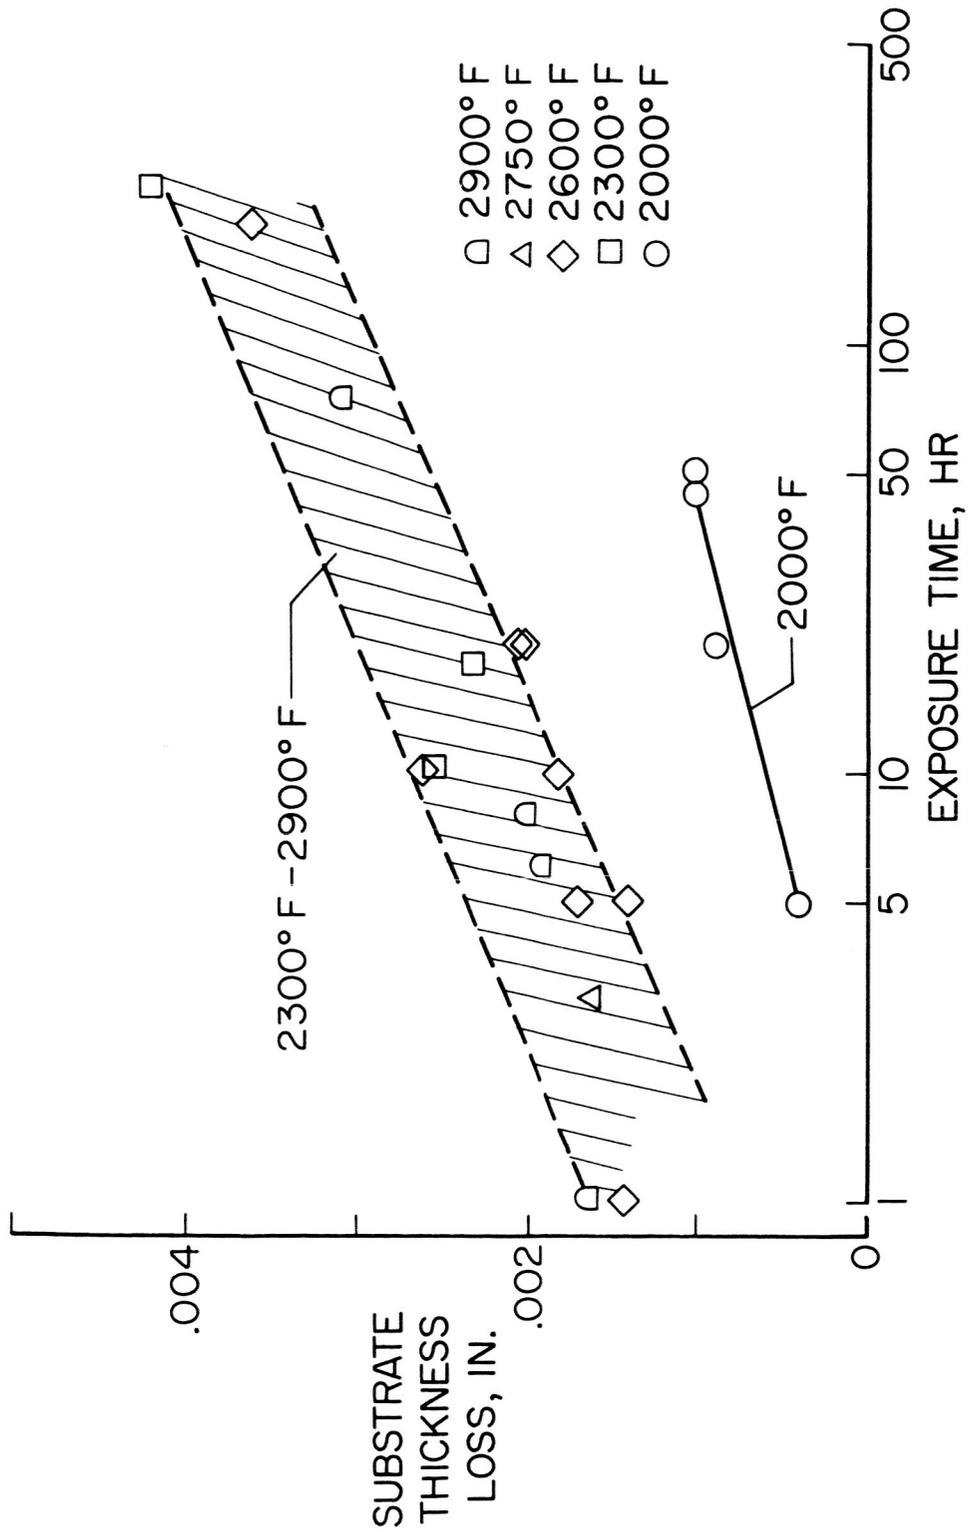
Figure 6.- Variation of substrate thickness loss with exposure time for Al-Sn-Mo (aluminide) coated Ta-10W alloy sheet at several temperatures.

One factor which could lead to an embrittlement of the coated-tantalum-alloy sheet was noted. This was the loss of substrate thickness due to solid-state diffusion of aluminum into the substrate, widening the brittle aluminide layer at the expense of the substrate. Evidence of this can be noted in the lower photographs of figure 5. The as-coated substrate (lower left) was approximately 0.0075 inch thick. After 20 hours exposure at 2600° F in air, the substrate thickness had decreased 0.002 inch due to the diffusion (lower right, fig. 5). A plot of the substrate thickness loss for specimens of the Al-Sn-Mo coated-tantalum-alloy sheet after various exposure conditions of temperature and time in air at atmospheric pressure is shown in figure 6. It is apparent that there is an increase in substrate thickness loss with increasing temperature from 2000° F to 2300° F for a given exposure time, as would be expected. However, from 2300° F to 2900° F the substrate thickness losses were of approximately the same magnitude for a given exposure time and curves drawn through the points for these temperatures will overlap. Accordingly, all data points for test temperatures from 2300° F to 2900° F have been bracketed in the shaded area of figure 6. A possible explanation for this behavior may be a more rapid increase in the rate of formation of the aluminum oxide layer in the coating compared to that of the aluminide layer with increasing temperatures. This could cause depletion of aluminum in the aluminum-tin-molybdenum layer in the temperature range from 2300° F to 2900° F (ref. 4). Similar results were obtained in reference 7 for aluminide-coated Ta-10W alloy.

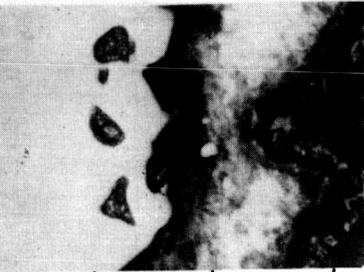
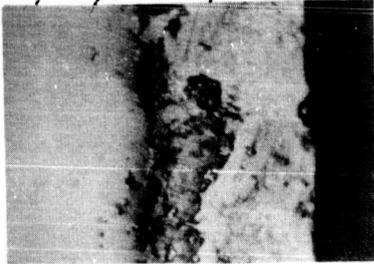
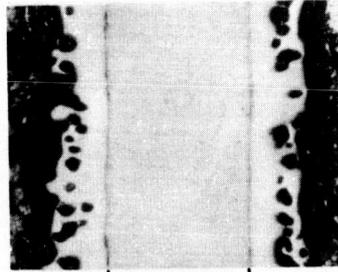
EXPOSED, 1 ATM  
2600° F, 20 HR

AS COATED

Figure 5.- Sections of Al-Sn-Mo (aluminide) coated Ta-10W alloy sheet.

A possible explanation for the improvement in dynamic oxidation coating life with an increased molybdenum content in the coating may be arrived at by considering the nature of this coating. As shown in the upper photomicrographs of figure 5, the as-coated specimen on the left contains a layer of one or more aluminides adjacent to the substrate and an outer layer of Al-Sn-Mo. As indicated in the upper right of figure 5, during high-temperature exposure the aluminide layer remains solid but grows by solid-state diffusion of aluminum into the substrate. The Al-Sn-Mo layer is a viscous liquid, with molybdenum aluminide particles acting to increase its viscosity. An outer layer of aluminum oxide forms on the surface of the specimen. It is this outer aluminum oxide layer which is thought to supply the oxidation resistance with the liquid layer underneath supplying aluminum to heal breaks in the outer  $Al_2O_3$  layer. During the dynamic oxidation tests, the liquid layer appeared to flow along the specimens under the shearing action of the airstream, depleting the coating at the stagnation point of the specimen, where failure most often occurs. The new coating with the higher molybdenum content appears to have a more viscous liquid layer, thus resisting this flowing effect and providing longer protection for the substrate.
